Norpol Gelcoat Guide to Better Quality

This Norpol Gelcoat Guide to Better Quality will help ensuring that you part manufacturing is done right, deficiencies in application are recognised in an early stage, and you have a solution on hand for further improving robustness of operations. You will find specific examples of surface defects, with our recommendations for resolution.

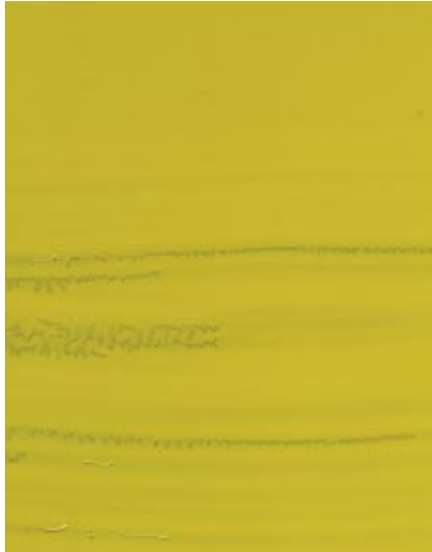
Print Through

CAUSE:

- Can see through gelcoat film due to poor covering of unevenly applied or too thin gelcoat film

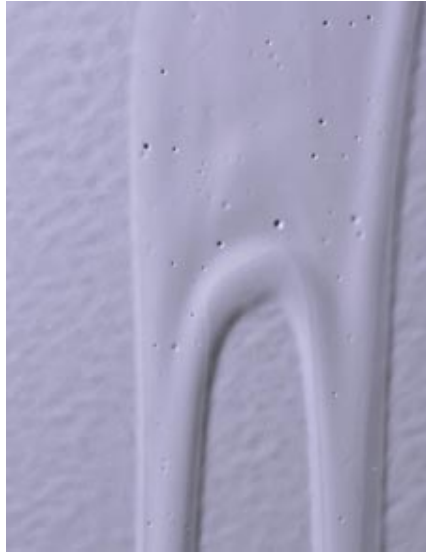
Sagging

CAUSE:

- Too high gelcoat film thickness
- Gelcoat viscosity too low
- Wrong spray tip
- Too long geltime

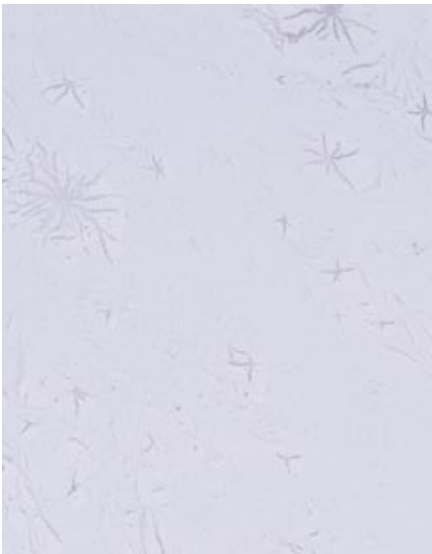
Dust in Mould

CAUSE:

- Dust and dirt on mould prior to gelcoat application, in some case due to static electricity

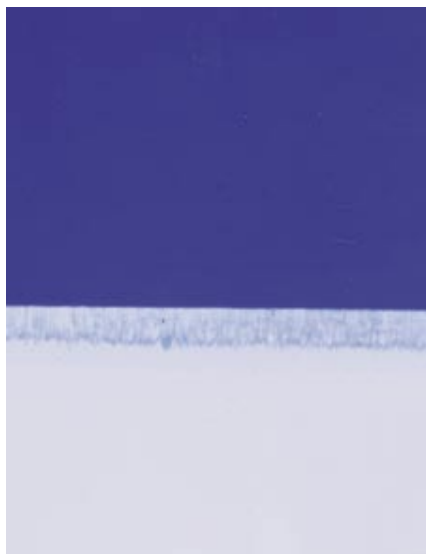
Bleeding

CAUSE:

- Poor film cure of "striping" gelcoat
- The second coating "dissolving" back of strip coating

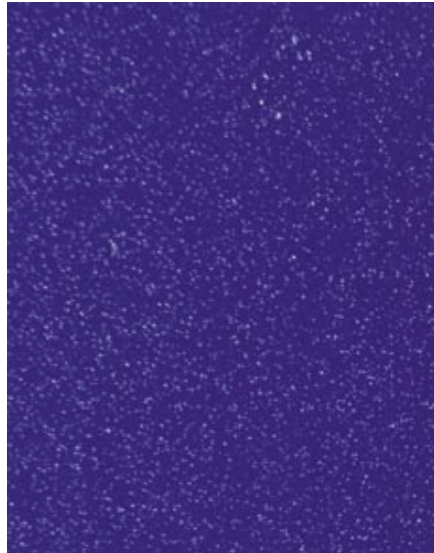
Porosity

CAUSE:

- Gun too close to mould
- Gelcoat viscosity too high
- Wrong type or contaminated peroxide
- Peroxide level too high
- Gelcoat film too thick
- Gellime too fast
- Water or solvent contamination
- Too high spraying capacity (too big tip) compared to shape of mould

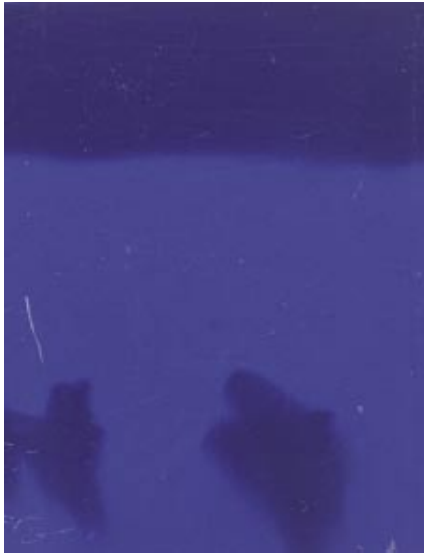
Fading or Bleaching

CAUSE:

- Undercured gelcoat film
- Water exposure to dark colours
- Exposure to harsh chemicals

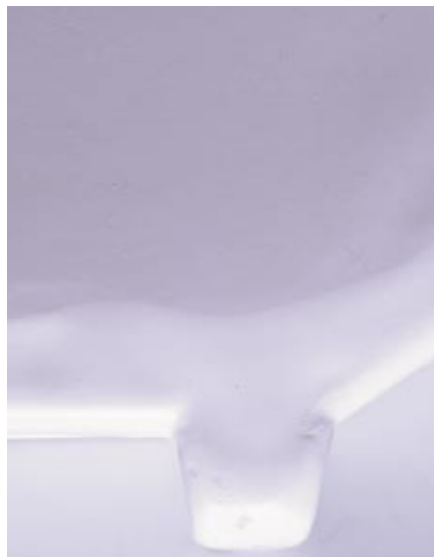
Pre-Release

CAUSE:

- Peroxide level too high
- Gelcoat film too thick
- Uneven film-thickness around radius causing uneven cure and shrinkage
- Uneven cure due to styrene vapour in deep areas of the mould
- Gelcoat film allowed to stand too long before laminating
- Wrong type/ application of mould release agent
- Contamination on mould surface
- Laminate excessively resin rich

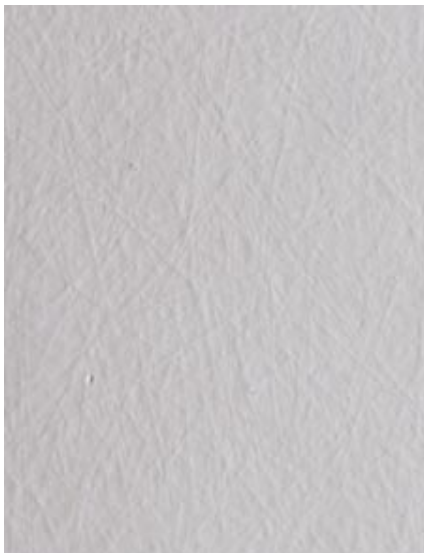
Fibre Pattern

CAUSE:

- Insufficient cure of product
- Pattern transferred from mould surface
- Glass texture too coarse
- Gelcoat film too thin
- Wrong laminating/ demoulding cycle

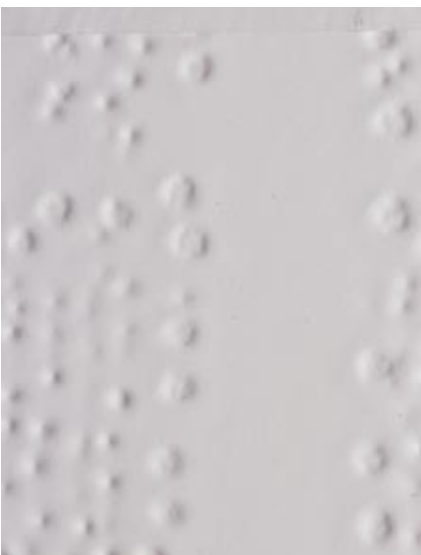
Fisheyes

CAUSE:

- Contamination of mould surface
- Gelcoat film too thin
- Viscosity too low
- Low atomisation pressure
- Excessive wax on mould
- Worn tip
- Pump pressure too low (airless)
- Inadequate mixing of gelcoat
- Type of wax/ release agent

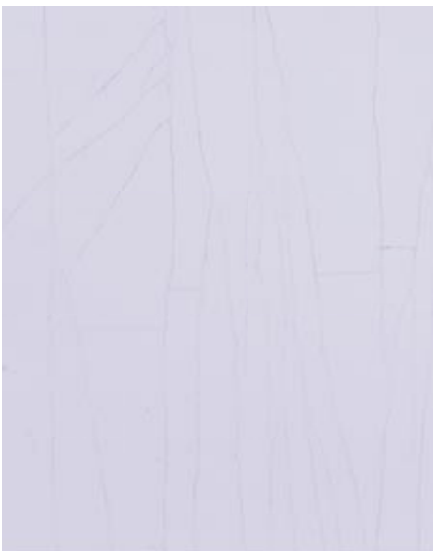
Cracking

CAUSE:

- Stress on the gelcoat surface from bending, impact or excessive force used to demould part
- Gelcoat film too thick
- Improper curing times or curing cycle
- Weak laminate
- Defect in mould

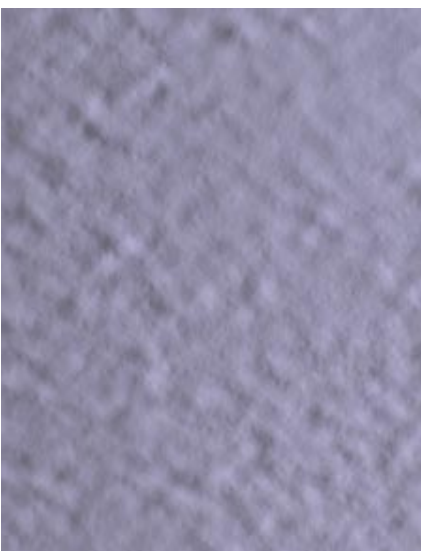
Poor Levelling

CAUSE:

- Viscosity too high
- Gun held too close to surface or at improper angle
- Atomisation pressure too low (air support systems)
- Low fluid pressure (airless systems)

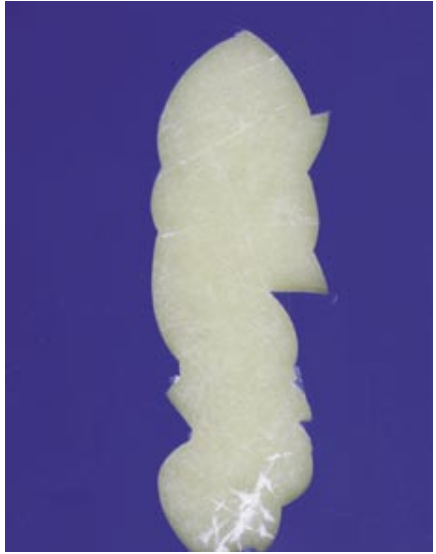
Poor Adhesion

CAUSE:

- Contamination
- Unevenly applied or wrong type of wax/ release agent migrating to gelcoat surface
- Over-cured gelcoat.
- Peroxide level too high or too long time before backup lamination was done.
- Laminating resins containing too much wax

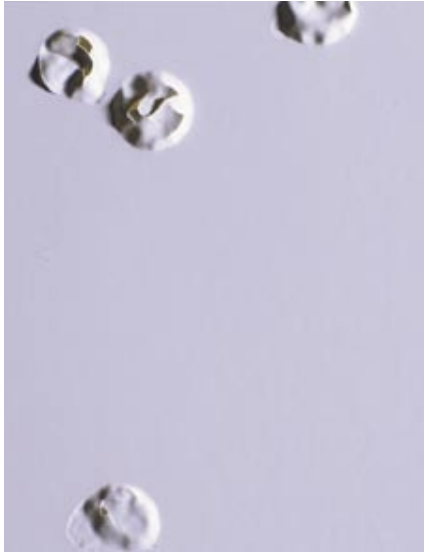
Blisters

Spot after Sun/ Heat Exposure

CAUSE:

- Poorly rolled laminate (air pockets)
- Peroxide droplets on gelcoat or in the glass fibre
- Solvent, water or oil present on gelcoat or glass fibre

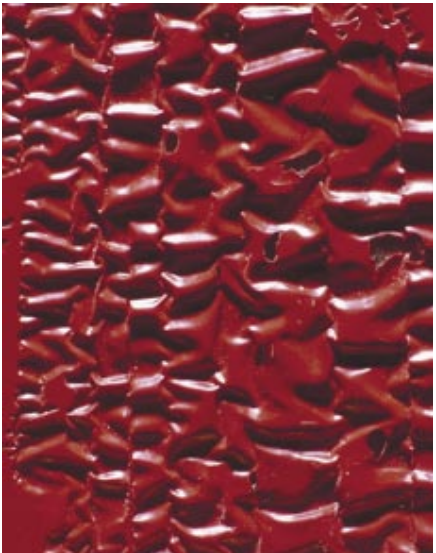
Alligatoring/ Wrinkling

CAUSE:

- Insufficient cure of the gelcoat film prior to application of back-up resin.
- Insufficient film thickness to resist attack of styrene in back-up resin
- Too long geltime

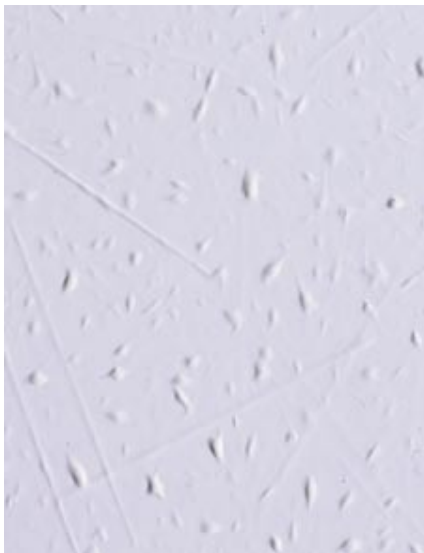
Blisters

Observed on Boats, Tanks and Spas after Water Exposure

CAUSE:
